PowerGen Europe 2009

Ageing Generator Rotor: Refurbishment or removal from service?

Günter Ebi, Sensoplan AG, Germany

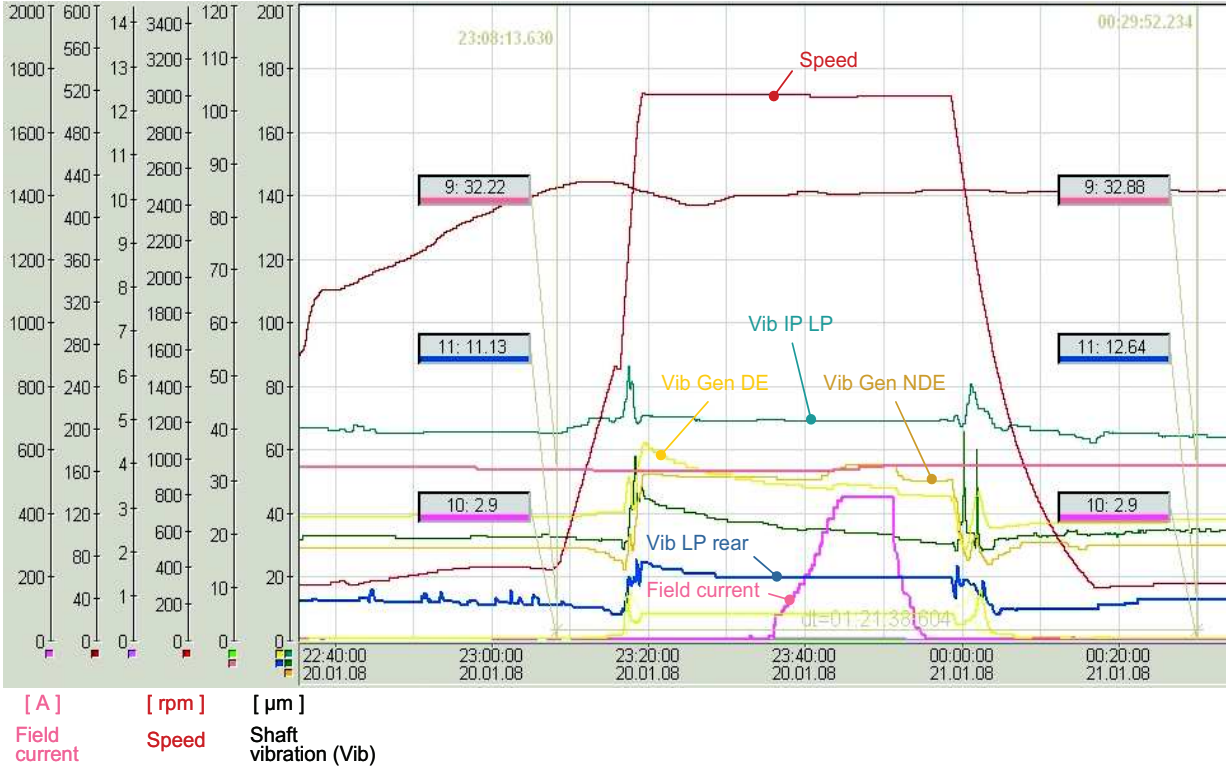
Figure 1 shows the shaft displacement amplitudes of the generating set during test A. A field current of approximately 450 A produced a voltage of 10 kV (rated voltage 10,75 kV) for about 15 minutes in the no-load saturation test. During this period the change in vibration

level was marginal indicating that a thermal unbalance created by the field current was not likely to be the root cause of the problem.

Figure 1: No-load saturation test, field current was raised to 450 A producing a generator voltage of 10 kV (voltage line not shown in this graph).

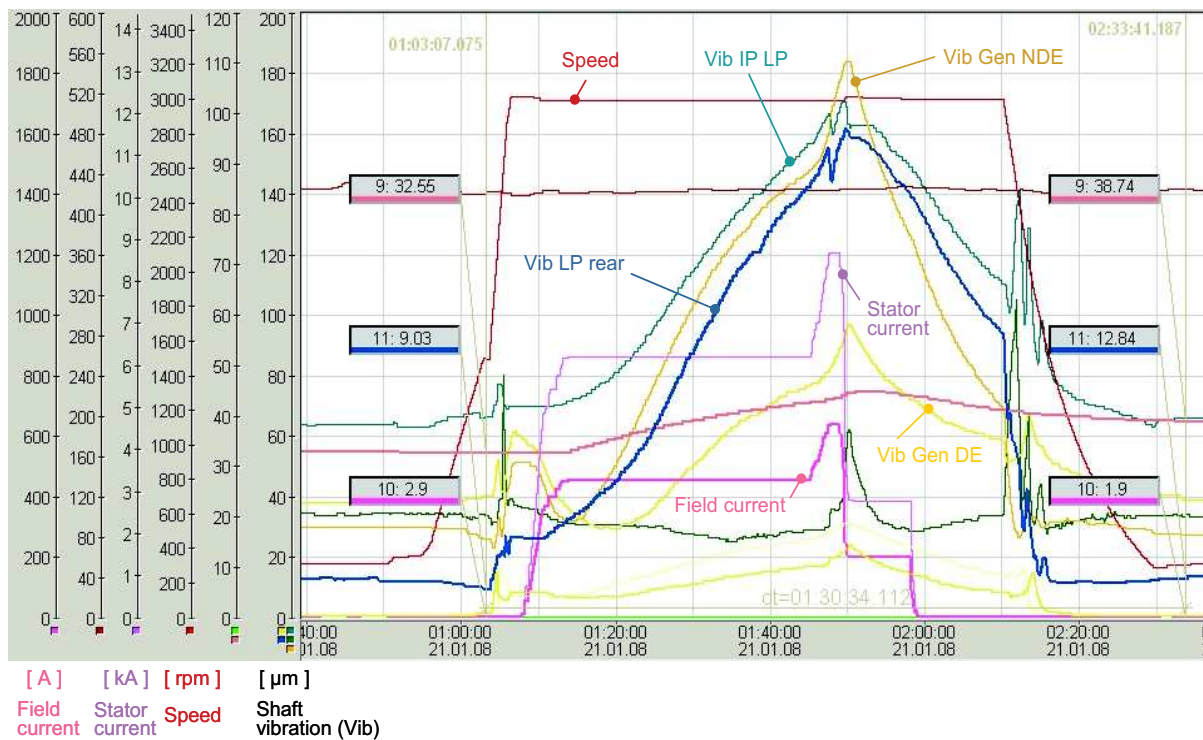
Figure 2 displays the vibration response during test B. A stator current of about 6.000 A (50% of rated value) produced a strong increase in vibration amplitudes. When the current was further raised to 8.400 A (65% of rated value) the rate of increase of vibration level was even steeper. Finally, the test was stopped when the shaft displacement at the generator non-driven end (NDE) had reached a maximum amplitude of 180 µm. Apparently, at 50% load the damper winding was no longer capable of carrying the damper current without detrimentally affecting the rotor performance. Also, the higher the damper current the stronger was the impact on the rotor unbalance.

The test results clearly identified the damper system as a probable root cause of the vibration problems, while the field current had less impact on the vibration level.

Figure 2: Sustained short-circuit test, maximum stator current reached 65% of rated current.

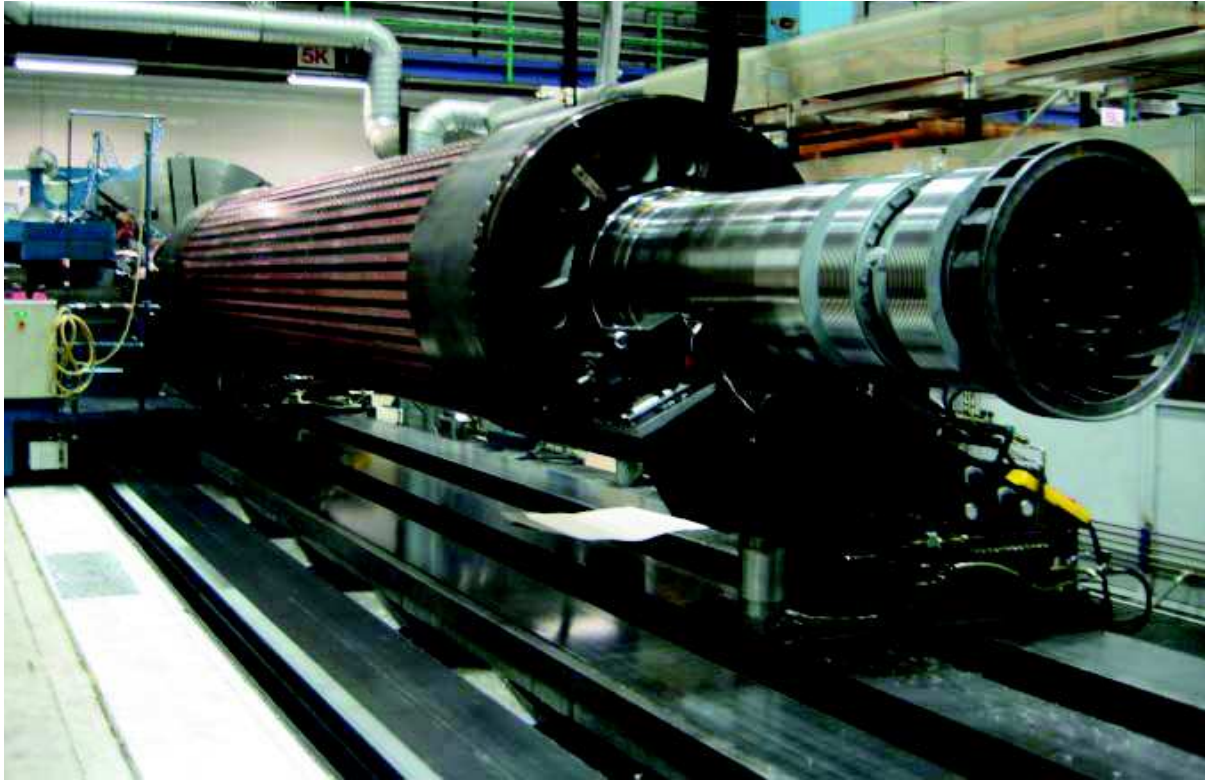
Figure 3: 110-ton rotor of 138 MVA single-phase generator

After the 110-ton rotor (Figure 3) arrived at the rotor service shop, electrical, mechanical and visual inspections were performed. The electrical tests indicated two interturn faults, but the insulation resistance was still in good condition, as was the mechanical run-out of the shaft at the bearing and coupling locations.

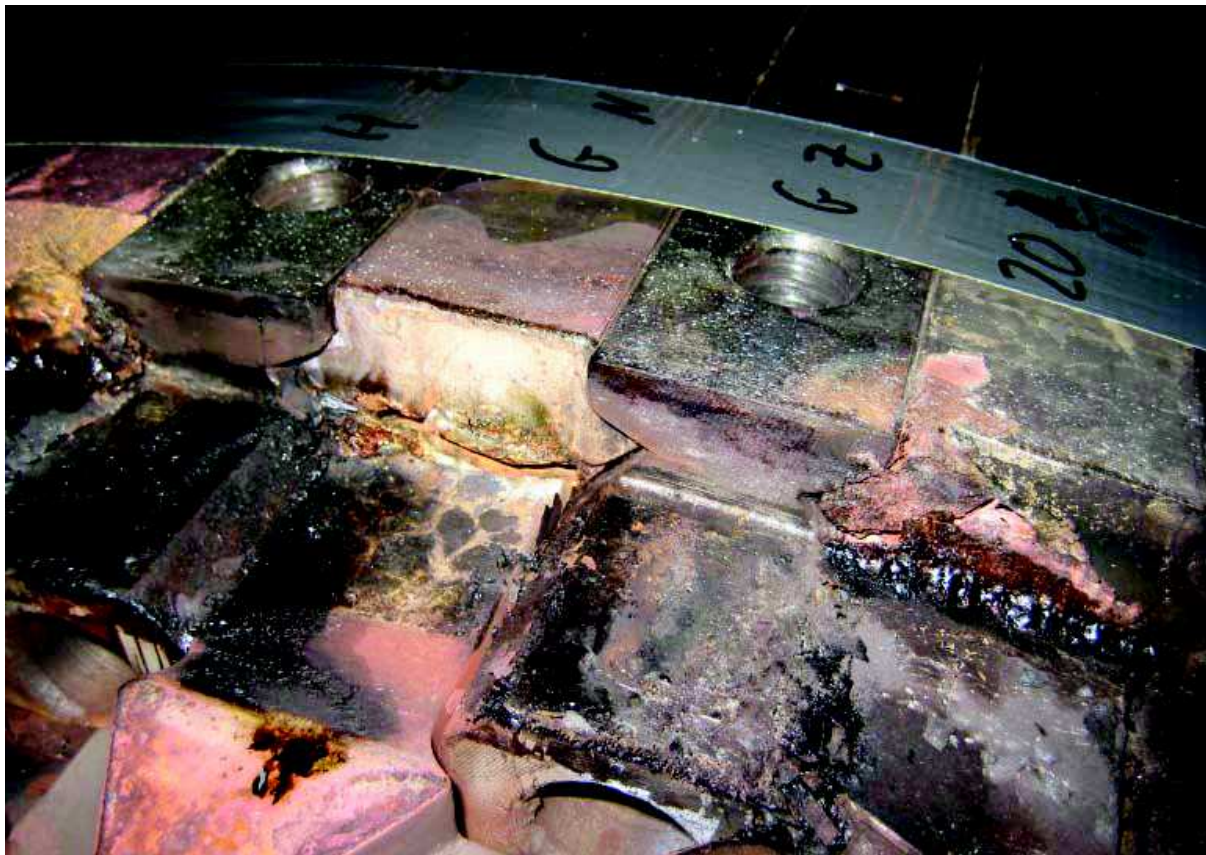
The first visual inspection revealed traces of molten copper from wedge ends and black debris in the gap between the retaining ring and rotor body, indicating that hot-spot temperatures of around 1100 °C (the melting point of copper is 1084 °C) had been occurring in the shrink seat area. As a consequence, the shrink seat insulation between the rotor body and retaining ring had burned up, producing the visible black debris described above. In single-phase generator rotors, the shrink seat is insulated to avoid high damper current entering the retaining ring.

After the removal of the retaining rings and the damper basket insulation, significant damage was found on the driven end retaining ring, the wedges and the damper basket (Figure 4). The front end of the retaining ring facing the rotor body in the pole area also showed localized melting over a length of about 200 mm. At some locations visual inspection revealed cracks in the molten zones – probably caused by large thermal stresses. The retaining rings were

Figure 4: View of NDE rotor shrink seat area after removal of retaining ring

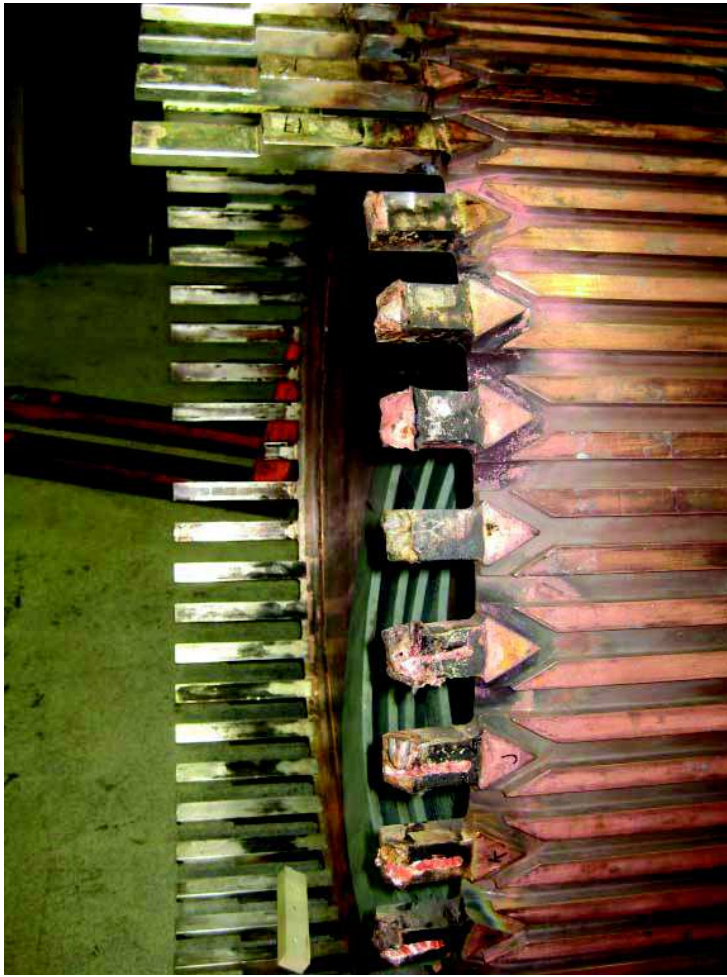
As with the retaining ring, the damage on the wedges and damper basket was mainly in the pole zone of the rotor. The wedge ends showed extended cracking and melting. Consequential damage to the rotor teeth could not be excluded at this point. After moving one wedge towards the rotor NDE, it became apparent that the primary cause of the melting was related to cracking of the damper basket fingers. A total of 14 fingers on DE were completely broken off (Figure 5), and one finger on NDE was cracked.

Figure 5: Damper basket NDE, 14 damper fingers were broken off

This represents an undefined electrical contact, leading to localized arcing and, consequently, the melting of the wedge ends. This arcing process was also responsible for the damage observed on the retaining ring. Such arcs carry high current densities capable of melting most materials. When driven by a stable and steady power source, their destructive power is enormous.

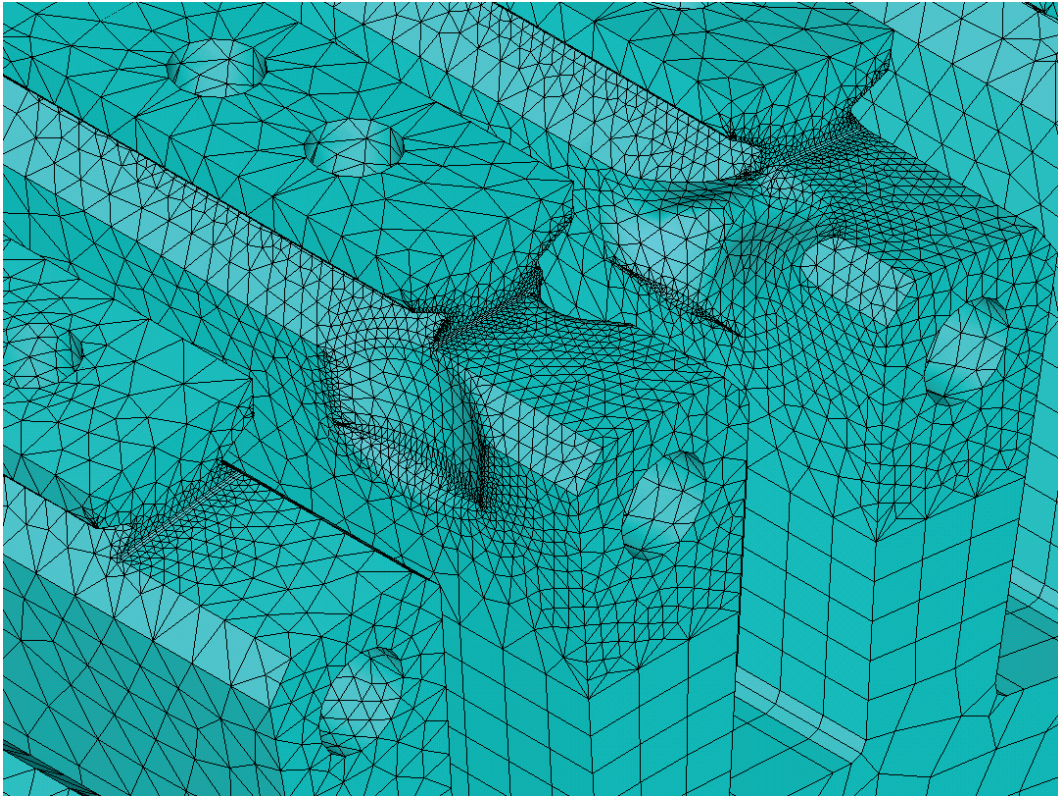
Next, casts from the melted zones on the rotor forging and retaining ring were produced using special plastics with zero shrinkage during curing. The casts were scanned to capture the precise geometry of the missing material on the rotor. Using a geometric computer model of the original rotor and subtracting the missing material based on the cast allowed a finite element model to precisely image the geometry of the damaged rotor to be built (Figure 7).

Figure 7: Finite-element-model of rotor shrink seat area showing the area with the removed material and the re-machined surfaces

Using Sensoplan's extensive experience in the field of generator calculations, the mechanical stresses in the rotor during operation, start-stop and faulty conditions could be determined quickly. The results were promising. Although, notch stresses exceeded the allowable values,

the overall results indicated the possibility of successful repair by removing the damaged material.

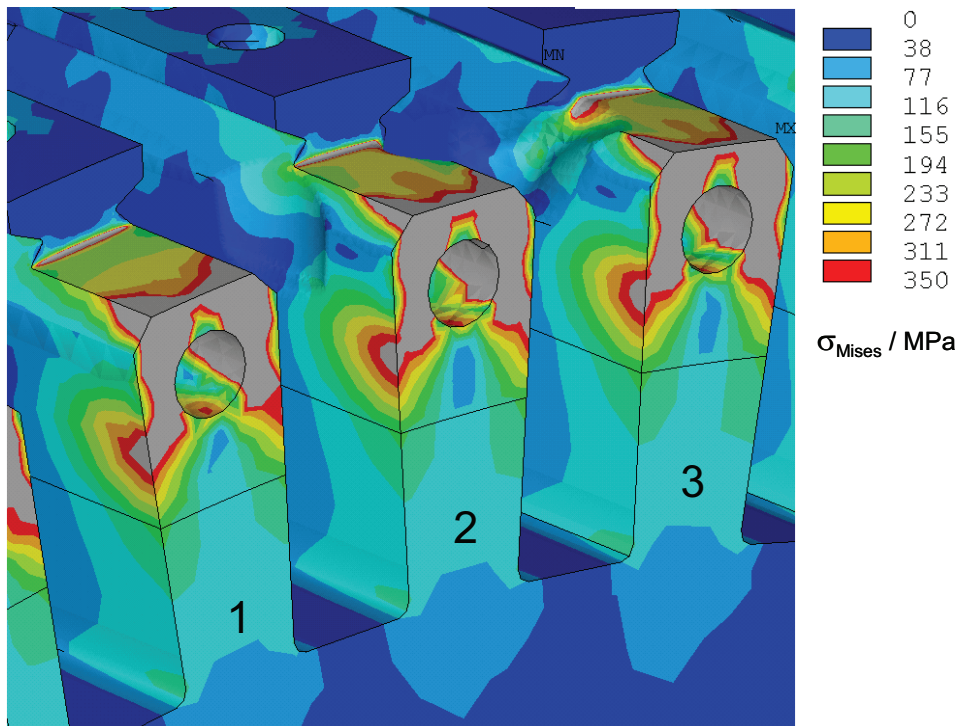
Figure 8 displays the distribution of the mechanical stresses in the teeth labelled 1, 2 and 3 at standstill when loaded with shrink forces. For better visualization of the rotor stresses the retaining ring is not shown. In the model the shrink forces are produced using contact elements in the entire shrink seat area between rotor teeth and retaining ring and applying an interference fit representing the true shrink fit dimension.

Tooth no.1 in figure 8 was not machined and still possesses its original geometry. In tooth no.2 and no.3 material was removed and they were re-machined to a new geometry at the transition between shrink seat and slot wall. Each tooth is subject to the same shrink forces. When the stress patterns for all 3 teeth are compared the differences are very small. This

result reveals that the removal of the material did not create significant additional stresses. The stress level in the modified rotor is nearly the same as in the original rotor.

Figure 8: Finite-element-model of rotor shrink seat area showing the area with the removed material and the re-machined surfaces

First, the winding was completely sealed off to avoid contamination with iron particles. In a repeating process, melted and cracked material was removed by milling and grinding, and dye-penetrant testing was performed on the newly machined and cleaned surface until no further crack indications were found. Casts were taken to capture the modified geometry. These were scanned and fed into the finite element model for recalculation. This allowed the identification of locations with stress raisers and to selectively re-machine these areas until the stresses were well below the allowable limit.

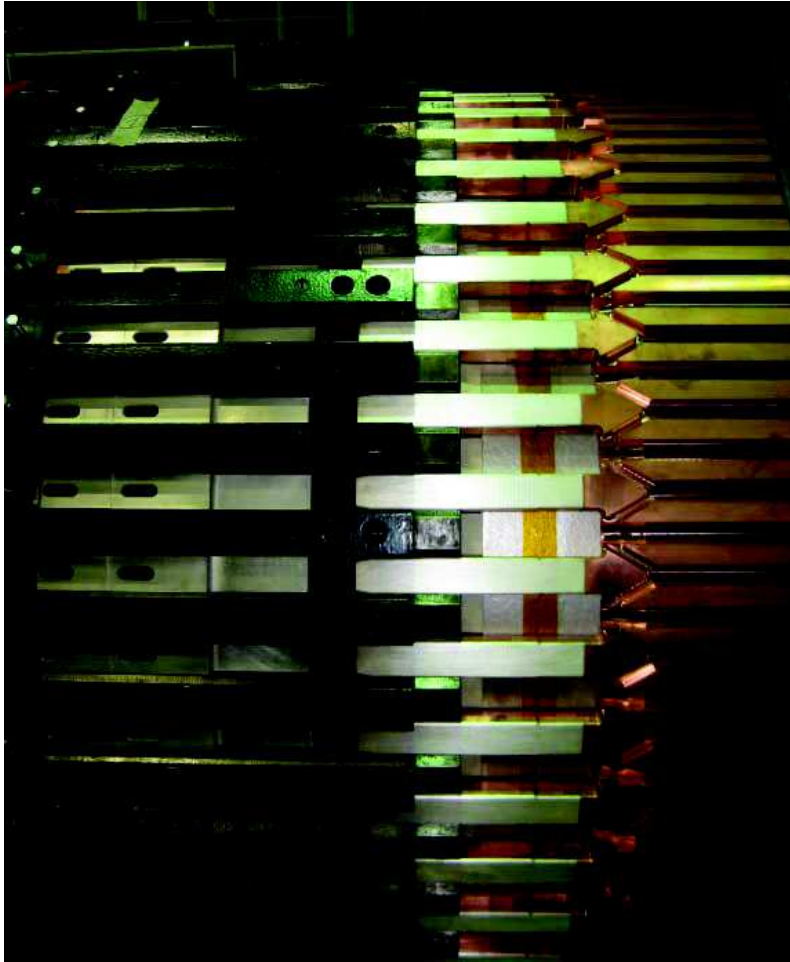
The fingers connect the damper bars in the rotor slots to the damper basket and are an integral part of the basket (Figure 6). When a finger breaks, the damper current flow is interrupted, forcing the current to bypass the fracture by continuing its path through the copper wedge and contacting the basket at the wedge end.

Figure 6: Reassembly of damper basket NDE, silver-coated damper fingers slide to the left on top of silver-coated damper bars

Reassembly of the rotor, balancing, and electrical and mechanical tests concluded the repair work.

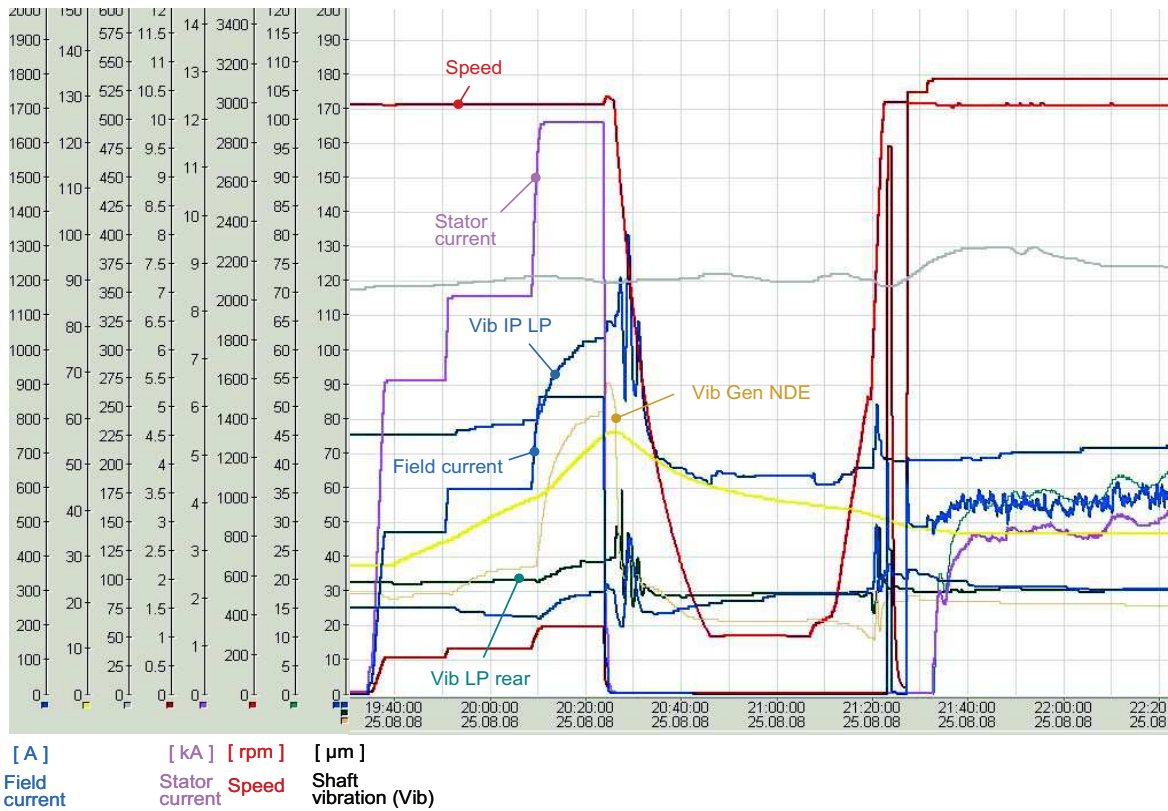
After installing the rotor and recommissioning the generator power plant management decided to perform a final sustained short-circuit test (test B) as acceptance test. The results are presented in figure 9. Test B was carried out between 19:35:00 and 20:25:00 on 25.08.2008. The stator current was increased in three steps from about 6.500 A (50% of rated load) via 8.300 A (65% of rated load) to 12.000 A (93% of rated load). Up to 65% of rated load the vibration level was hardly affected by the damper current (30 to 37 μm 0-peak at generator NDE) whereas prior to the repair a steep, six fold increase was observed. Near rated load the vibration amplitude reached a value of about 80 μm and was well within the acceptable limit according to ISO 7919:2. The tremendously reduced vibration levels confirmed the success of the generator rotor repair.

Figure 9: Sustained short-circuit test after repair, max stator current at 93% of rated value

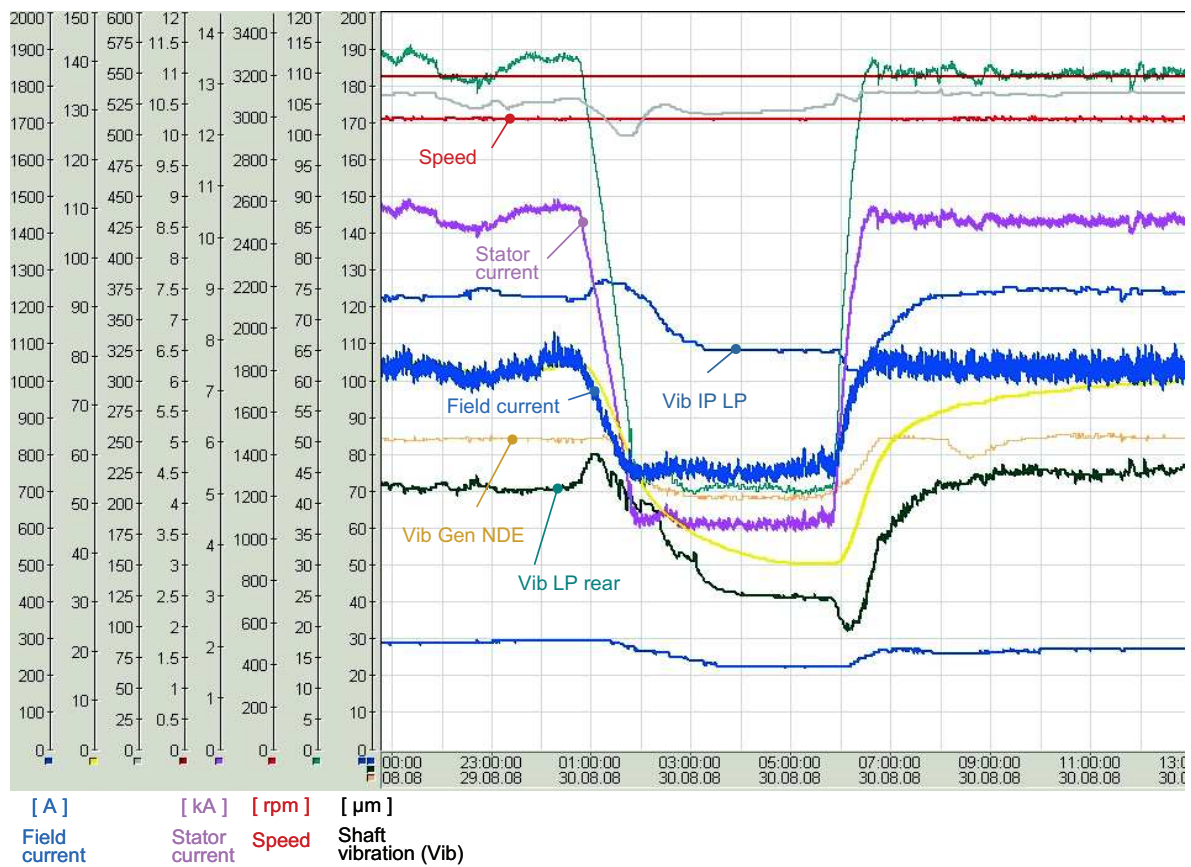
Figure 10: Load drop test after repair from nearly 100% down to 35% rated value

Figure 10 shows the results of a load drop test performed during operation on 30.08.2009. The generator load was reduced from nearly 100% down to 35%, kept at 35% for about 4 hours and raised back to full load afterwards. The influence of the load drop on the shaft displacement amplitudes is small and within the normal range for unrestricted long-term operation.
